Metallurgy for Industries

A Monthly News Letter

July, 2015

Corrosion mapping using PAUT

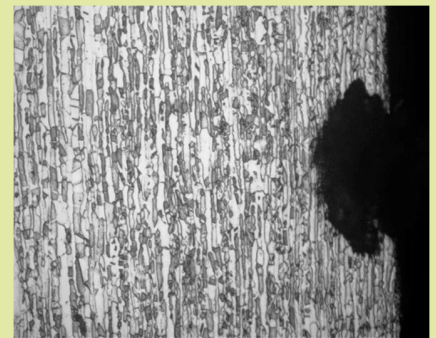
Microstructure of the Month

**Magnification:** 200X**MOC:** Duplex Stainless Steel - UNS32205**Component:** Buried cross-country pipeline**Observation:** the optical micrograph shows typical signature of pitting corrosion damage in the microstructure of elongated grains of ferrite and austenite.

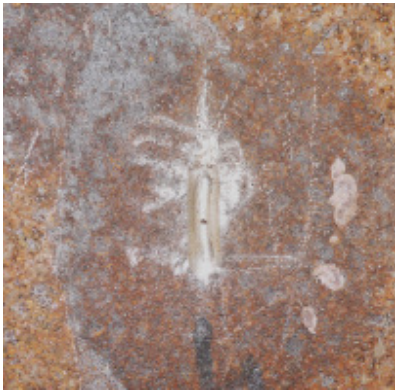
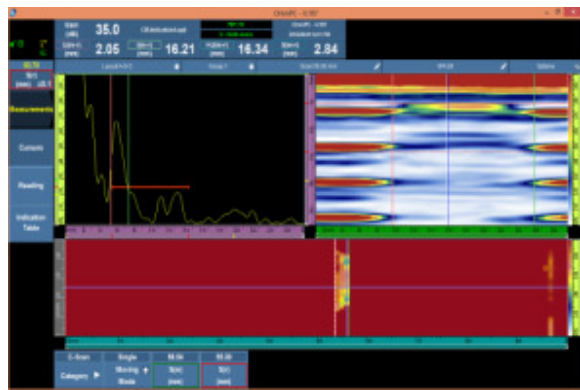
To simulate corrosion conditions, longitudinal and circumferential grooves were made on internal surface of pipe and same were mapped by PAUT.

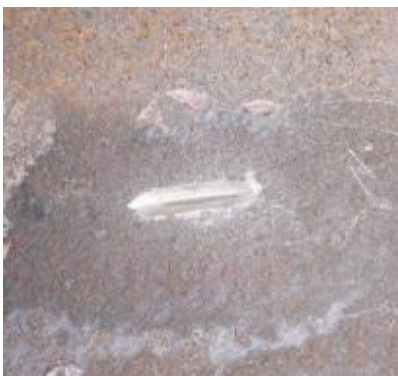
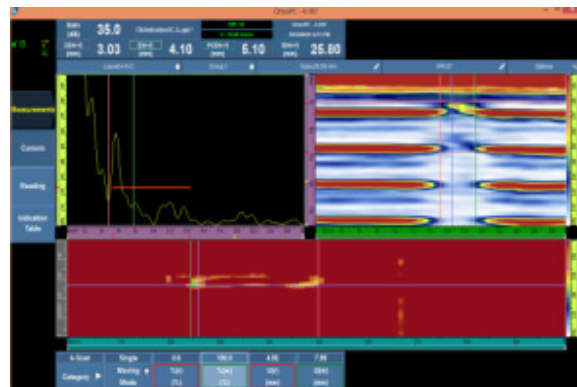
PAUT scans for above respective grooves are as under.
