# Metallurgy for Industries

## Boiler tube failure Investigation

*Damage mechanisms and mitigation*

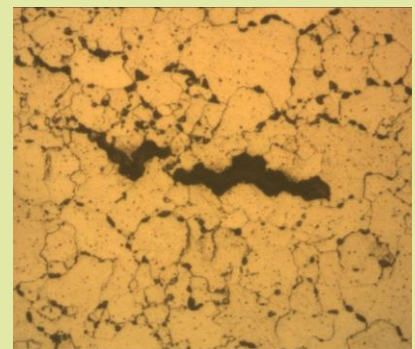
## Microstructure of the Month

**Magnification:**250x

**MOC:** Grade 14MoV6-3

**Component:**HRH turbine inlet pipe line

**Observation:**Presence of tertiary creep fissures and aligned creep cavities are observed at the grain boundaries. Microstructure shows degradation of bainite to carbides in ferrite matrix.

**Useful hints:**Optical Metallography is a useful tool in identifying material degradation; especially under advanced stage of creep damage.
